## TROOP C ARMORY

BUILDING NAME: Troop C/2nd Battalion/51st Regt. Armory

STREET ADDRESS: 1579 Bedford Avenue

The Armory Study

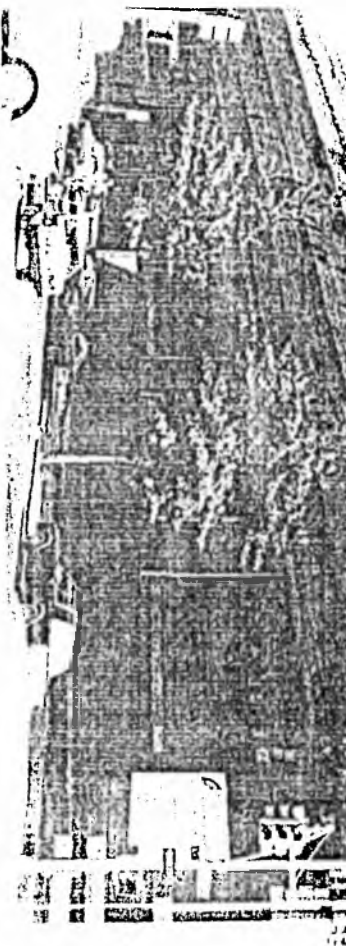
2

1. Elevation of headhouse on Bedford Street.
2. Elevation of drill shed along Union Street.
3. Elevation of former stable area along President Street.
4. View of drill shed.
5. Gymnasium entrance.

**ROOF & DRAINAGE:** Drill hall roof is in extremely poor condition. Roof drains into gutters on Union Street side which appear to be undersized for the load, since masonry below has been worn by water overflow.
